SITE ASSESSMENT REPORT
FOR
GENERAL DIE CASTING
DETROIT, WAYNE COUNTY, MICHIGAN
TDD # T05-9201-036
PAN # EMI1286SAA

March 25, 1992

Prepared For:
Mr. Duane Heaton
Deputy Project Officer
Emergency Support Section
U. S. EPA Region V

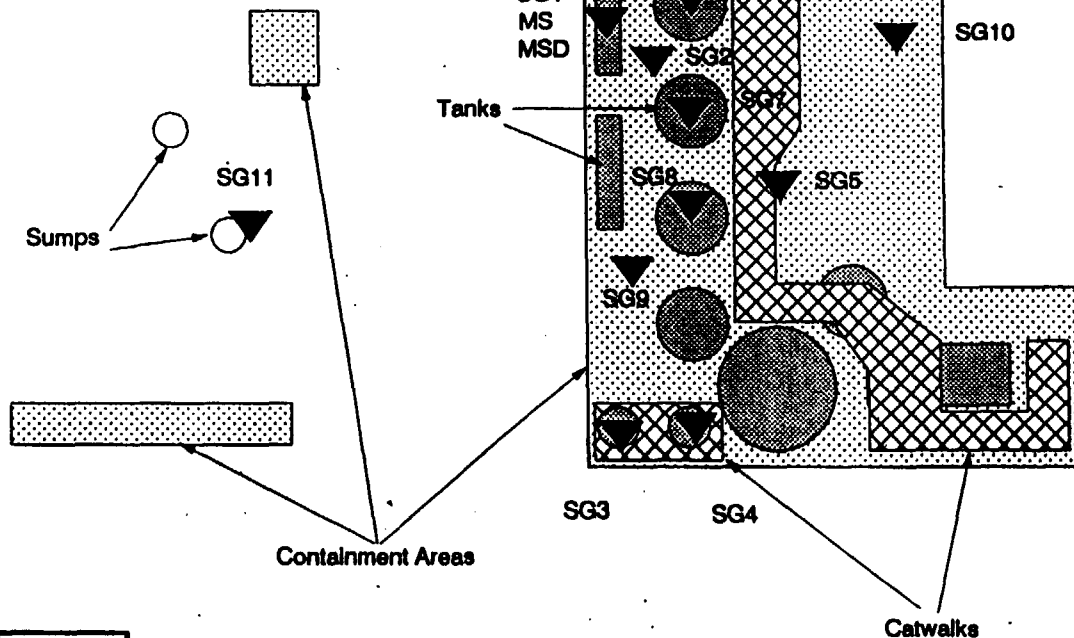
Sampling Diagram

gallons each. A tank used for treatment of chromium waste streams contained approximately 850 gallons of liquid. The one small tank along the south wall contained about 40 gallons of unknown liquid. Samples were taken from each of these tanks. Samples were also taken from residues and sludges found in other tanks, sumps, and containment areas (Figure 3).

SG1, MS, MSD	Green residue, nickel treatment tank.
SG2	White powder, small tank in nickel treatment.
SG3	Black liquid, tank on catwalk in nickel treatment.
SG4	White residue, tank on catwalk in nickel treatment.
SG5	White crystal, pipe below cyanide treatment tanks.
SG6, MS, MSD	Clear liquid, northern cyanide destruct tank.
SG7	Clear liquid, cyanide pH neutralization tank.
SG8	Clear liquid, chrome reduction tank.
SG9	Brown residue, floor of nickel treatment.
SG10	Brown residue, floor of main treatment area.
SG11	Multi-color residue, sump in main plating area.

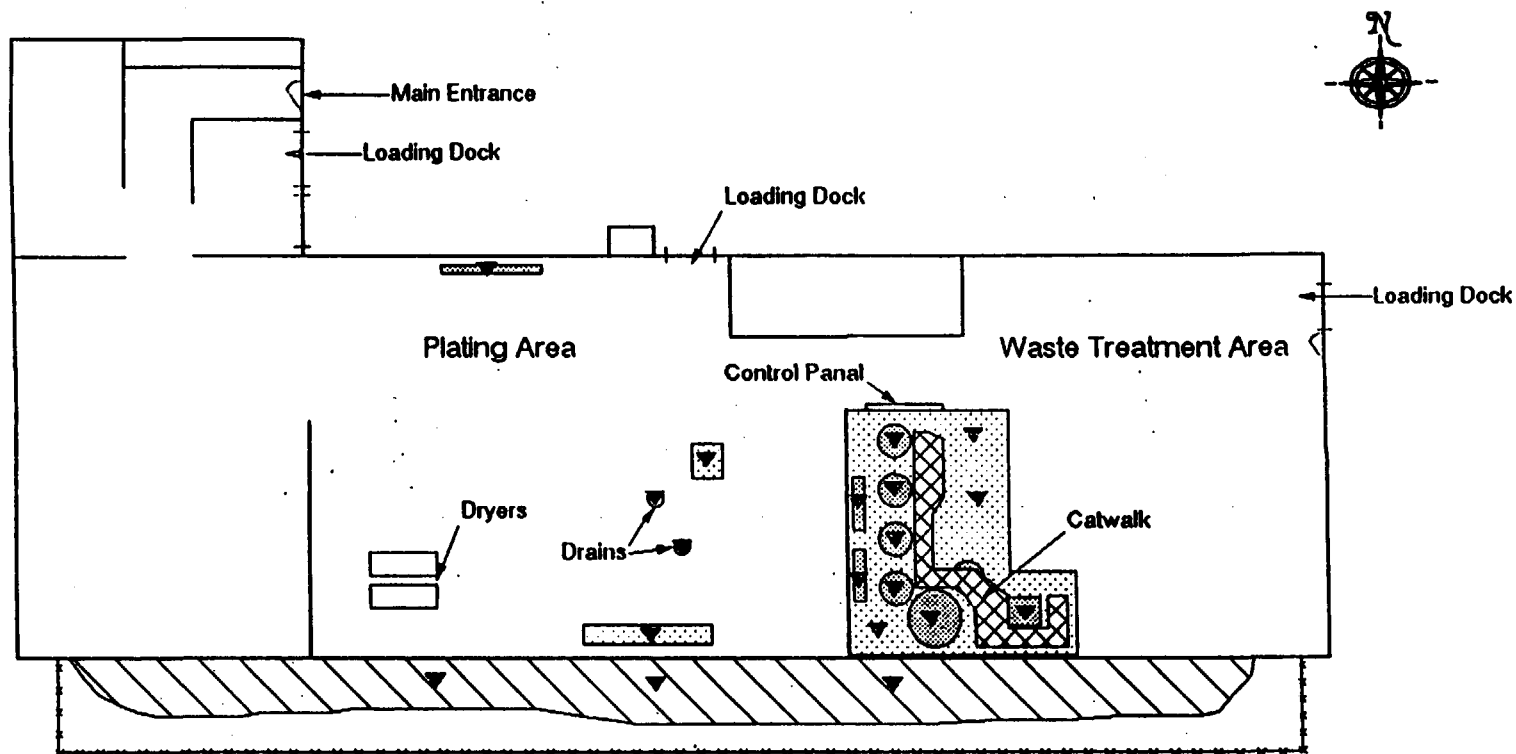
Sampling Map

Samples of solid materials from within the three containment areas will be collected. A total of 3 samples should be collected from the waste treatment area tank containment. The containment areas are in poor condition and the possibility for migration from these materials being washed through cracks in the concrete slab and foundation exist. These samples will also be analyzed for pH, total cyanide, and total RCRA metals including copper and zinc.

- ▼ Sample Points (Suggested)
- Tanks
- Containment Areas
- Fencing
- Backfilled Excavation
